Heritage Report:

Preservation of Brambridge Hatch on the Itchen Navigation

Polly Whyte (2011)

**Produced by the Hampshire and Isle of Wight Wildlife Trust
on behalf of the Itchen Navigation Heritage Trail Project partnership**

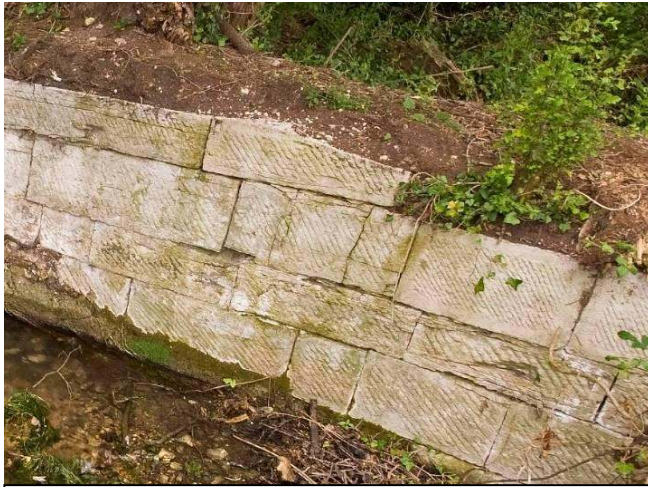
*Dressed stone with tooling on vertical faces
(Photo © Dennis Bright)*

Mike Clerk from Hampshire County Council's Historic Environment team inspected the structure and commented: *'The main walls of the structure are constructed of dressed stone, which is extremely rare on the Itchen, and indeed across the whole of Hampshire, which has little naturally occurring stone. The use of dressed stone, with tooling on the vertical faces, indicates a high value structure. Unusually, the operating mechanism for the hatch, which raised and lowered the timber boards to control the flow of water, is located on the downstream of the structure.'*

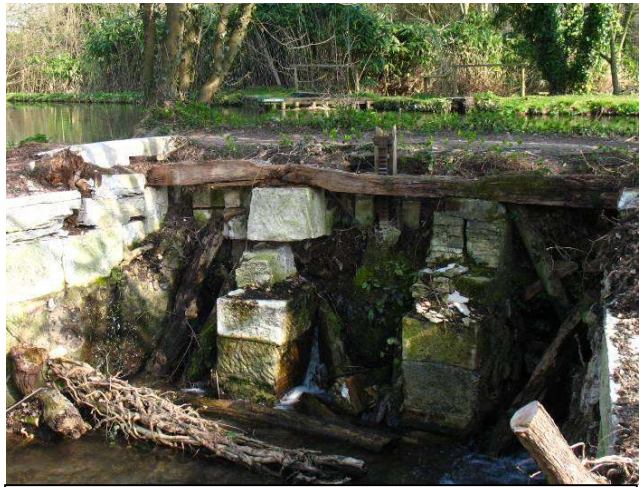
*Ironwork from hatch mechanism on downstream
side of structure*

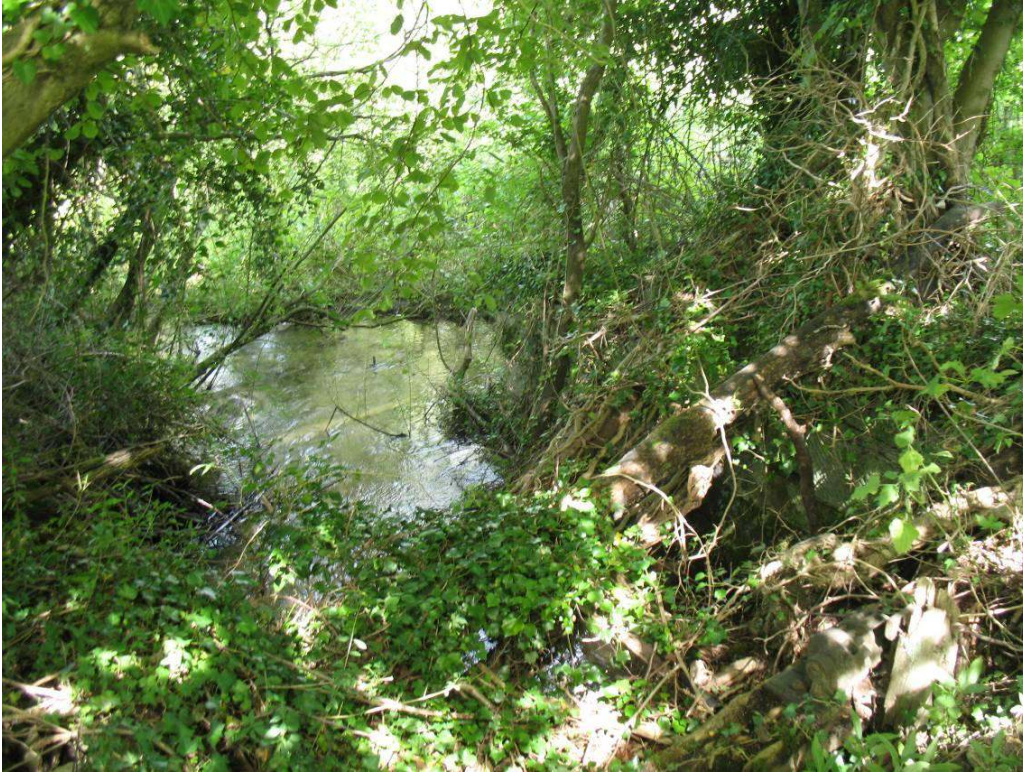
Before vegetation clearance work by Polly Whyte (Apr 2008)

In November 2008, a volunteer work party set to work to remove vegetation that was covering and damaging Brambridge Hatch. The vegetation clearance revealed that Brambridge Hatch is a large structure constructed of stone which originally had three hatches to take water from the Navigation.

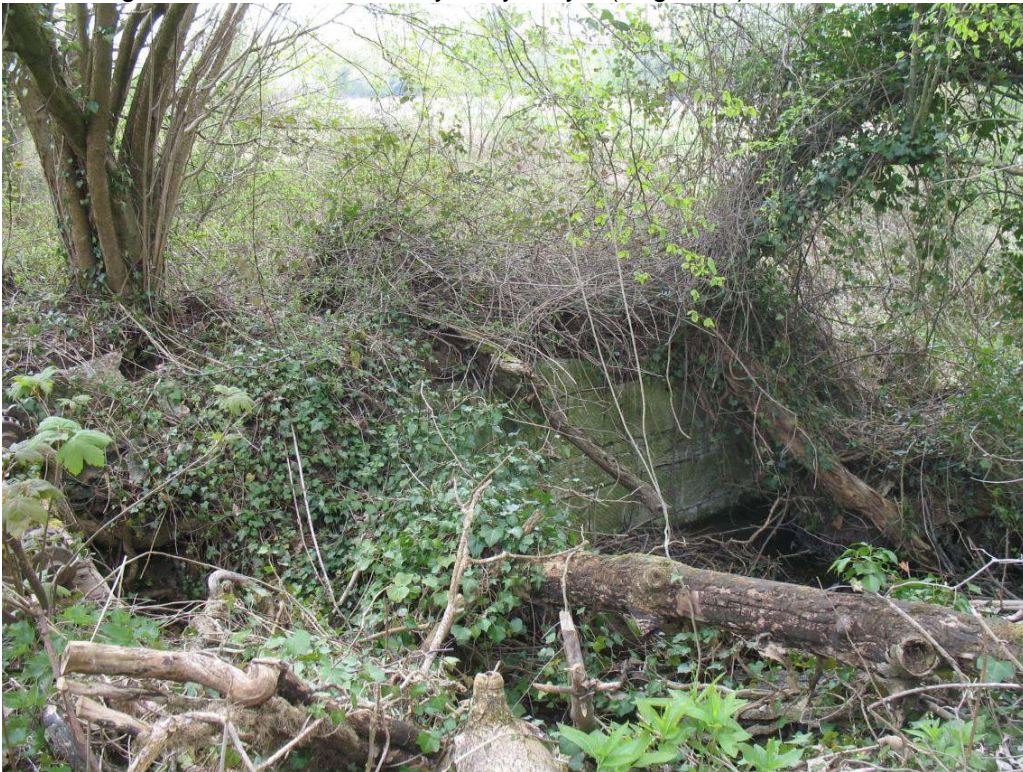
Before vegetation clearance work by Polly Whyte (Aug 2008)

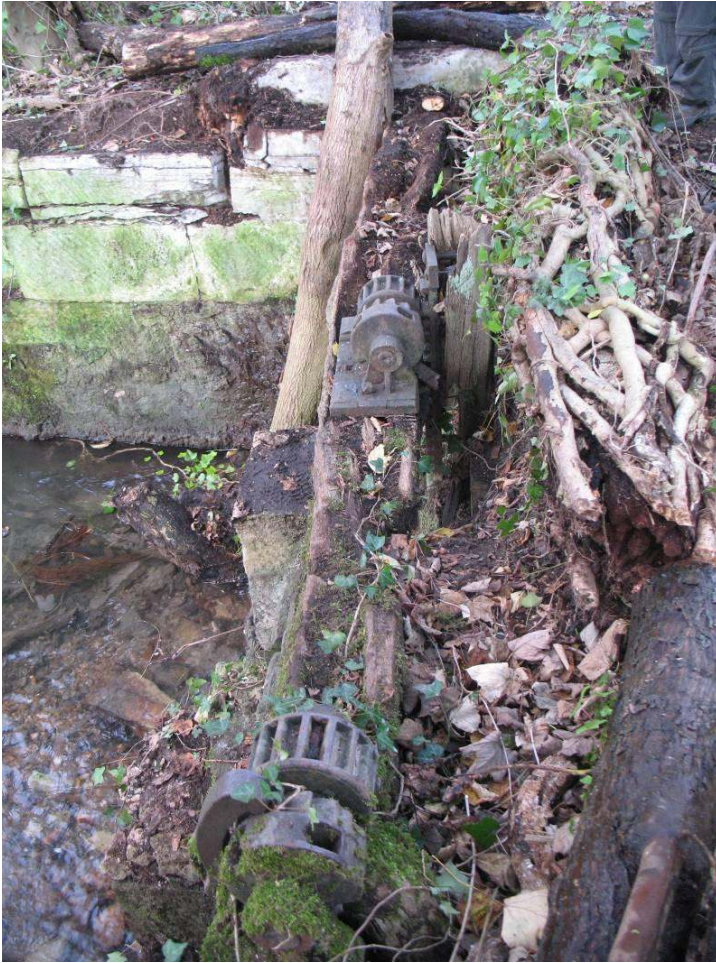
Exposed ironwork after scrub clearance by Polly Whyte (Nov 2008)

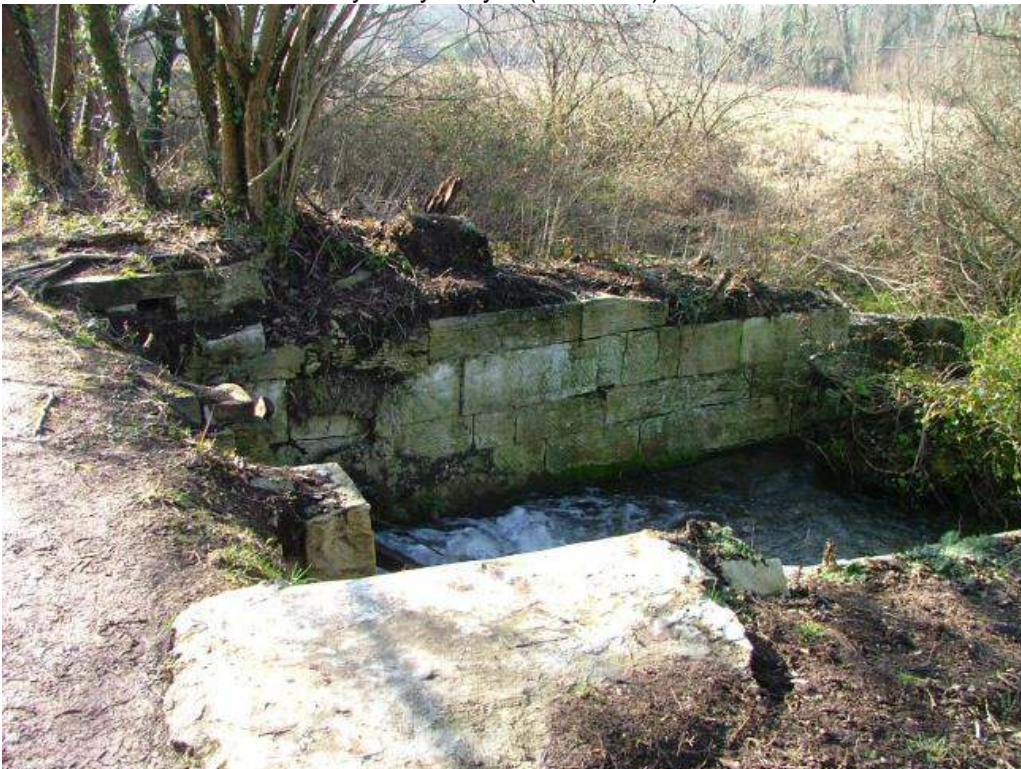
After scrub clearance work by Polly Whyte (Mar 2009)

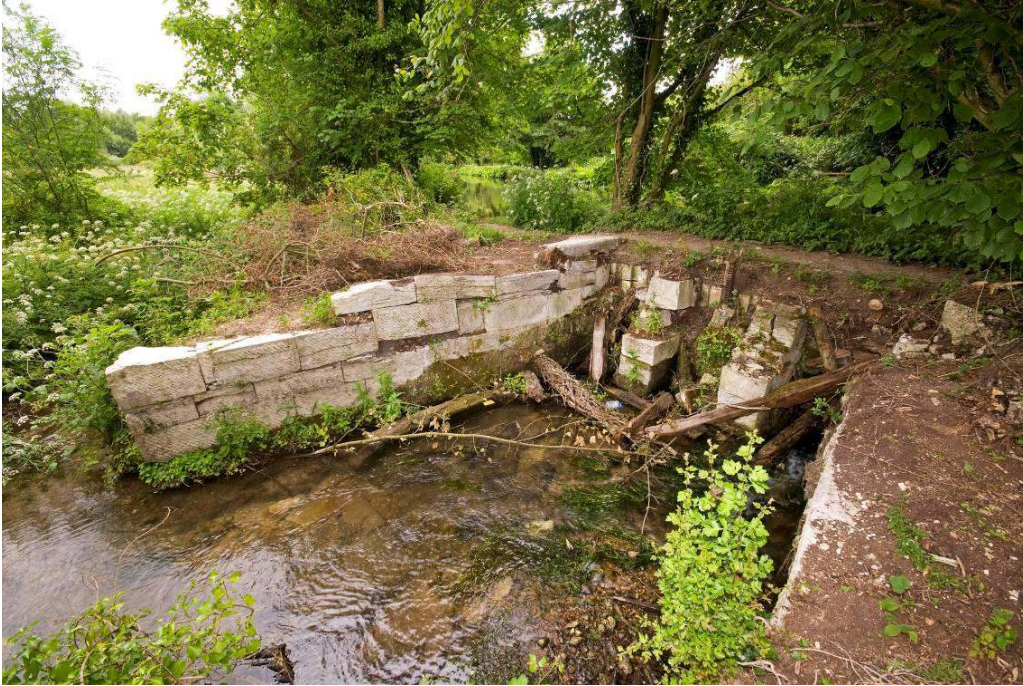
After scrub clearance work by Dennis Bright (Jun 2009)

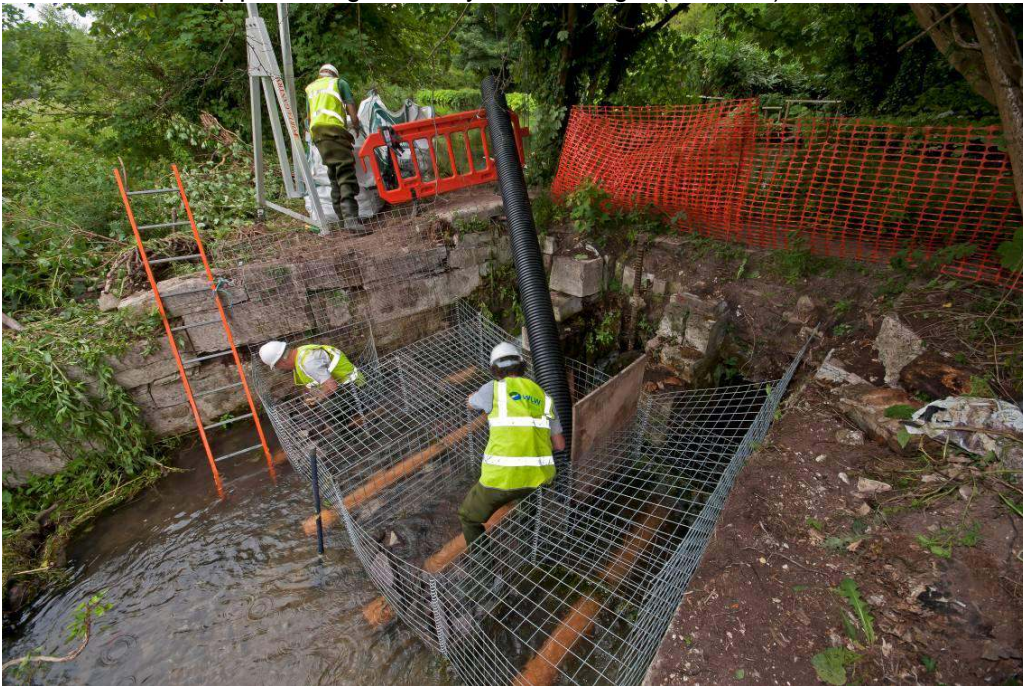
Installation of the pipes and gabions by Dennis Bright (Jul 2010)

- Stone gabions were installed to support the structure in a stepped design to leave uppermost stonework exposed.
- Pipes were installed underneath the gabion to allow water conveyance.

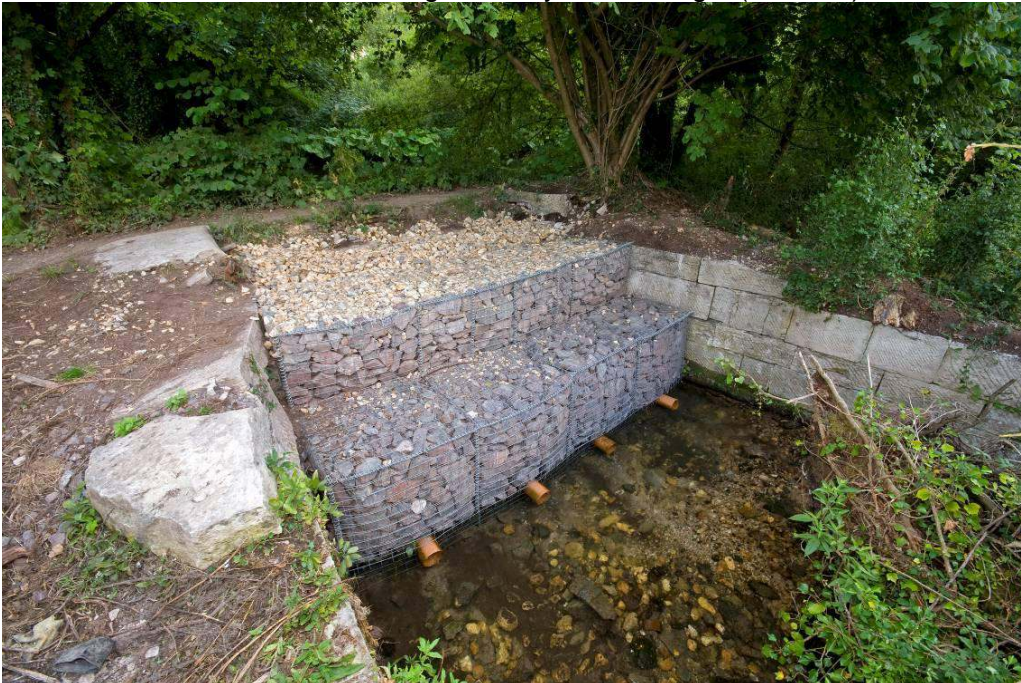
After installation of the stone-filled gabions by Dennis Bright (Jul 2010)

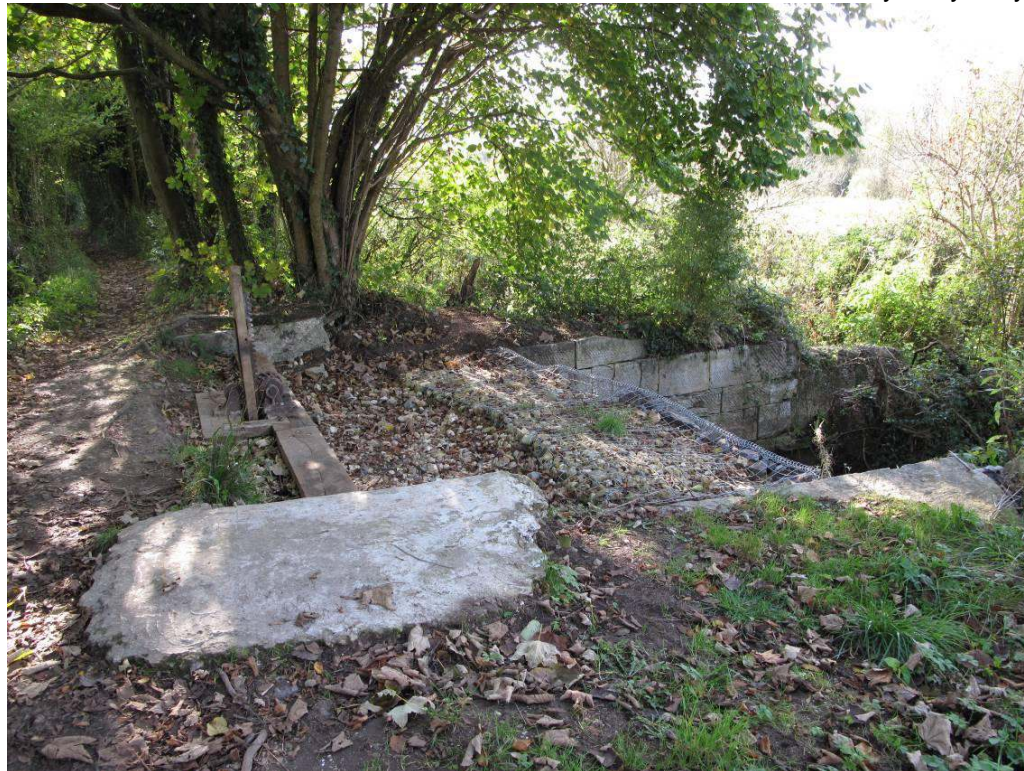
After installation of new oak beam with old hatch mechanism attached by Polly Whyte (Oct 2011)

In 2011, a replacement oak beam was installed and the remaining cast iron hatch mechanism attached to it. One metal mechanism was stolen from the site after the initial vegetation clearance.
