Heritage Report:

Preservation of Mansbridge Lock on the Itchen Navigation

Polly Whyte (2011)

Produced by the Hampshire and Isle of Wight Wildlife Trust on behalf of the Itchen Navigation Heritage Trail Project partnership

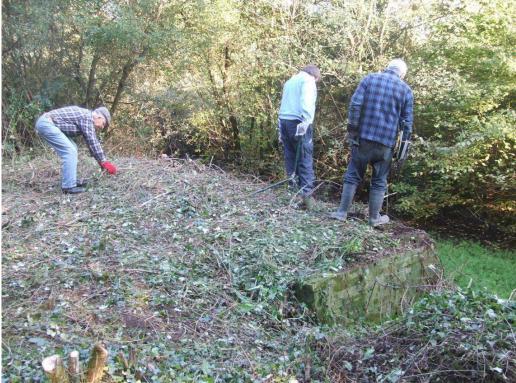
During scrub clearance by Bob Painton (Oct 2008)

When the lock was examined by Itchen Navigation project staff in 2007, very little of the structure was visible due to tree and scrub growth. Scrub and small trees were cleared from around the head and tail of the lock by volunteer groups from October 2007 to January 2009. Herbicide stump treatment was used on tree stumps on top or close to the brickwork. Remains of the built structure of the lock were found at the head and tail of the lock, both brickwork and stonework. The brickwork at the head of the lock was more complete, although a void in the brickwork was visible in the NW gate pier. A wooden footbridge with brick foundations has been built directly over the tail of the lock.

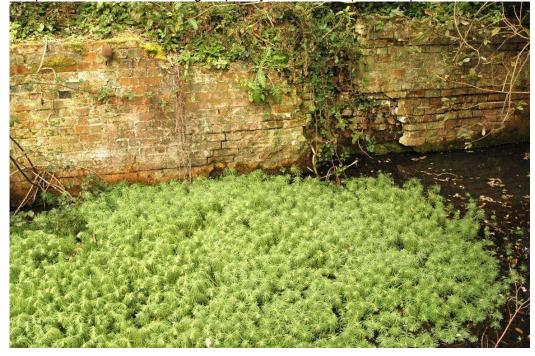
Contractors rebuilding NE gate pier by Polly Whyte (Nov 2009)

- moss and vegetation were scraped off from the front of the brickwork
- tree stumps growing into brickwork were removed
- brickwork joints were raked out and re-pointed
- bricks damaged by frost were pieced in individually
- voids in the brickwork were deep pointed
- lime capping was added to the top edge of the brickwork to shed water away from it

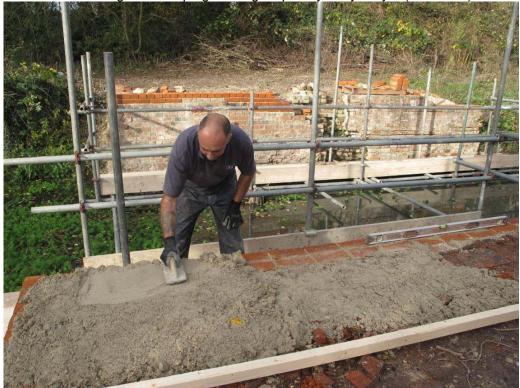
Contractors repairing SE gate pier by Polly Whyte (Nov 2009)

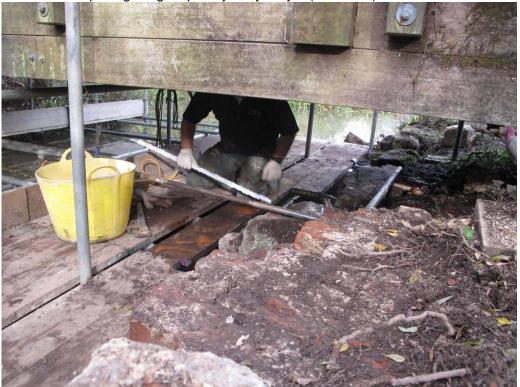
SE and SW gate piers by Polly Whyte (Nov 2009)

In addition, Cintec anchors were installed on the NW, SE and SW gate piers.

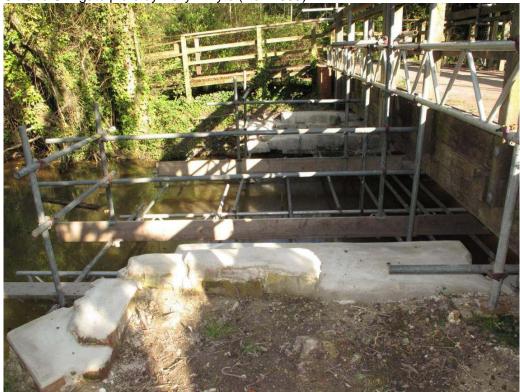
Mansbridge Lock following brickwork repair by Dennis Bright (Jun 2010)
