Heritage Report:

Preservation of St. Catherine's Lock on the Itchen Navigation

Polly Whyte (2011)

Produced by the Hampshire and Isle of Wight Wildlife Trust on behalf of the Itchen Navigation Heritage Trail Project partnership

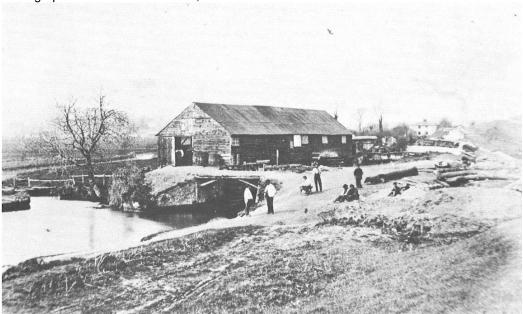
Photograph of St. Catherine s Lock, waterwheel and timber mill c.1870

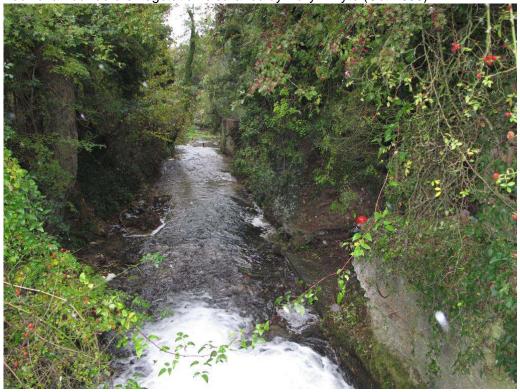
Lock chamber before vegetation clearance by Polly Whyte (Oct 2009)

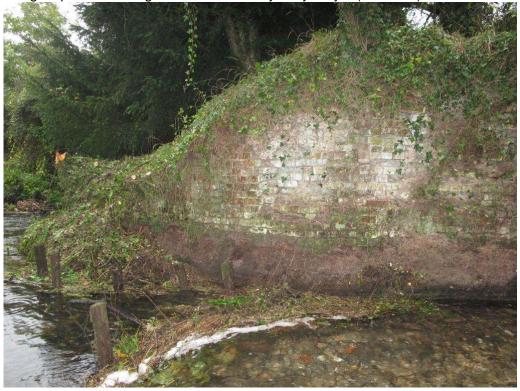
SW gate pier before vegetation clearance by Polly Whyte (Oct 2009)

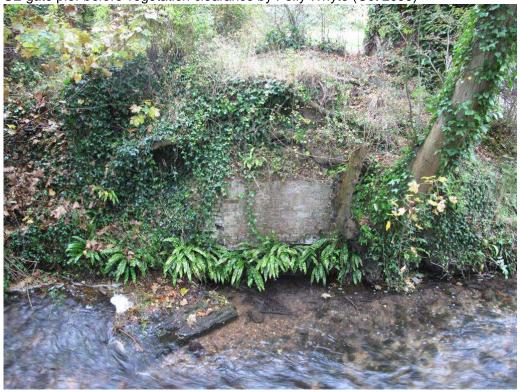
SE gate pier before vegetation clearance by Polly Whyte (Oct 2009)

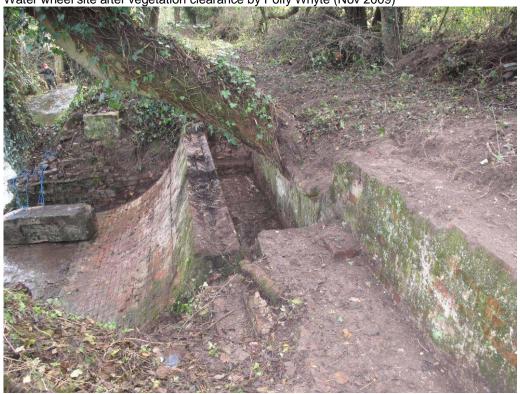
Water wheel site after vegetation clearance by Polly Whyte (Nov 2009)

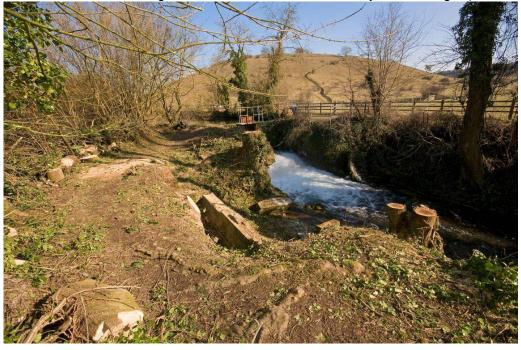
North end of lock after vegetation clearance and tree work by Dennis Bright (Mar 2010)

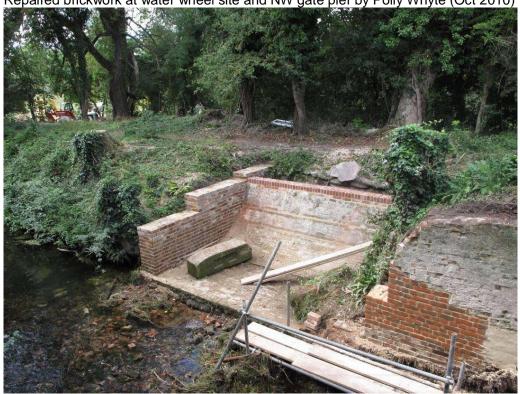
Repaired brickwork at water wheel site and NW gate pier by Polly Whyte (Oct 2010)

- Brickwork joints were raked out and re-pointed
- Irregular brickwork was consolidated
- · Voids in the brickwork were deep pointed
- Brick coping was added to the top edge of the brickwork to shed water away from it
- Cintec anchors were installed on the NW, SE and SW gate piers.
- Three :bat bricks were installed in the SE gate pier to mitigate for loss of any potential bat roost sites (although gaps adjacent to the brickwork still exist as potential roosting sites).

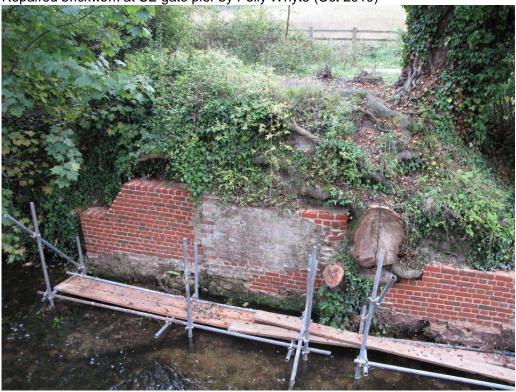
Repaired brickwork at SE gate pier by Polly Whyte (Oct 2010)
