This pamphlet describes some of the river engineering works undertaken to preserve and improve this precious waterway for wildlife and for people, as well as some of the accompanying events and activities which celebrated the wildlife and heritage of the Navigation.

The Itchen Navigation Heritage Trail Project

The Itchen Navigation Project, 2007 – 2012

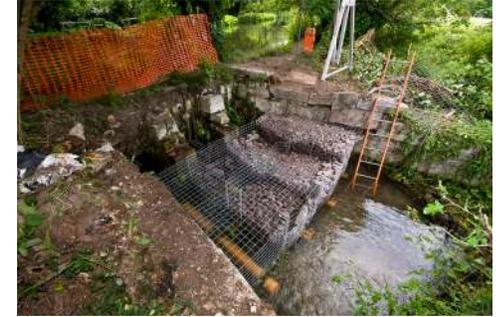
Vegetation clearance revealed that Brambridge Hatch was a large stone structure, with three hatches that took water from the Navigation. Metal hatch mechanisms were still present where the drain passed under the footpath. Material used to block the hatches had failed, and water was leaking into the structure, threatening it, and the Navigation's bank in which it sat, with collapse.

Stone-filled gabions prevent the stonework of Brambridge Hatch from collapsing

Stone gabions were installed in 2010, to support the structure and prevent further deterioration. A stepped design left the uppermost stonework exposed. Pipes installed underneath the gabions allowed water conveyance, and a replacement oak beam allowed the remaining cast iron hatch mechanism to be displayed.

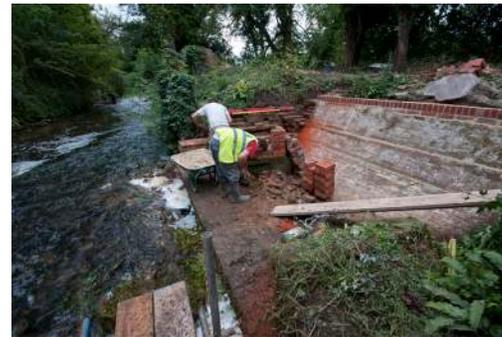
The site of the waterwheel that powered the adjacent timber mill is revealed at St Catherine's Lock.

2010, crumbling brickwork was replaced or consolidated, re-pointed, and tied back to the banks behind. Three 'bat bricks' were installed in the SE gate pier to mitigate for the loss of any potential bat roost sites, and curved brickwork which housed a waterwheel is now clearly visible.

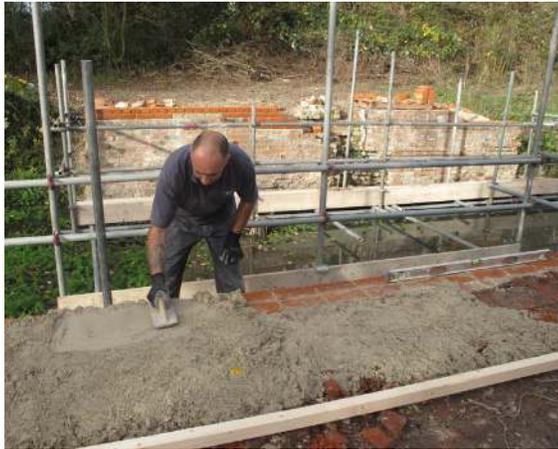
Contractors lay a bead of lime mortar to protect the restored brickwork below. Image: Dennis Bright

pointing was replaced. Bricks matching the dimension of the originals were sourced, and were laid to infill sections where bricks had been lost. Steel anchors tied the slumping walls back to the ground behind, preventing collapse. Finally, a protective capping of lime mortar was laid to protect the brickwork beneath.

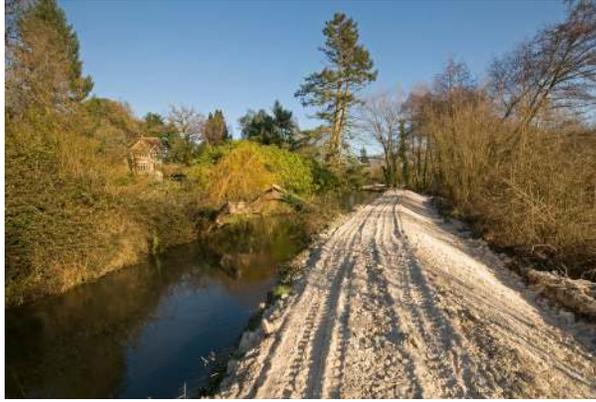
Rebuilding Allbrook's crumbling banks. Image Dennis Bright

Winter 2008 marked the start of engineering works, when work got underway at Allbrook to rebuild the crumbling banks. Here the 'perched' channel, raised above the surrounding landscape, had experienced bank collapses in the past, so was a priority for works.

A temporary bridge was positioned over the site of historic Ham Bridge, enabling access for machinery and materials, and preventing damage to the structure. Diggers and dumpers transported, laid, and compacted over 2000 tonnes of chalk to rebuild the embankment.

The eroded bank was widened to at least one metre wide at the top, to accommodate the footpath, and a back slope of 45 degrees provided stability. The footpath was resurfaced throughout the reach, and a spillway was installed upstream, to protect the bank and footpath from future high flows. Works were completed in early 2009.

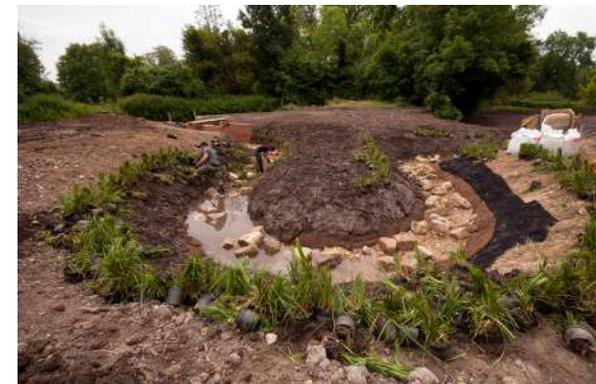
South of Shawford, Malm Lock and College Mead Lock both held up water behind them. Such structures can be a barrier to fish passage, preventing struggling salmon from reaching potential habitat upstream. They also impact other species, as the sluggish silted waters above don't provide the habitat required by chalk stream specialists, and the high water levels can also put pressure on the banks, leading to overtopping, erosion, or even catastrophic collapse.

The channel being constructed bypasses Malm Lock, enabling fish to reach the habitat upstream. Image: Dennis Bright

At College Mead, an aperture in the lock was widened to improve conveyance of water, preventing flows backing up and overtopping the banks upstream. However, water levels above Malm Lock were almost 2m above those downstream of it, and simply improving flows would not allow fish to overcome this barrier. Instead, a bypass channel was created around the side of the lock in 2012. This new channel was excavated and lined with rocks and gravels, carefully placed to provide a range of flow conditions passable by smaller fish as well as the more athletic salmonid species. The channel upstream is now freely flowing and as the gravel bed clears of silt, it is hoped that fish newly finding their way to this area will stay and spawn.

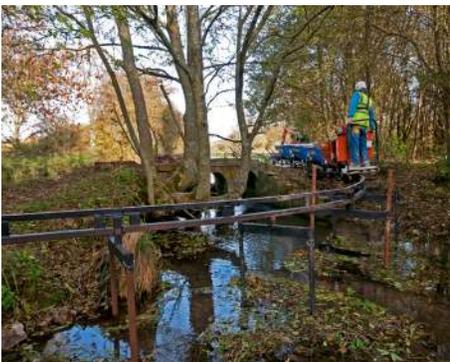
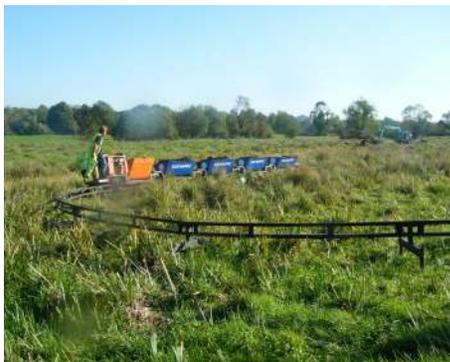
Hockley Monorail

As with other sites, access to undertake the works was problematic. Crossing the adjoining wet meadows would have been both costly and damaging to the habitat. Instead, a monorail was set up to transport the tools and materials needed to stabilise the banks, resurface the footpath, and enhance the river's margins.

The small engine was efficient, the tracks could be laid like sections of a train set to direct the monorail to wherever was needed, and the many stanchions spread the load, protecting the habitats beneath.

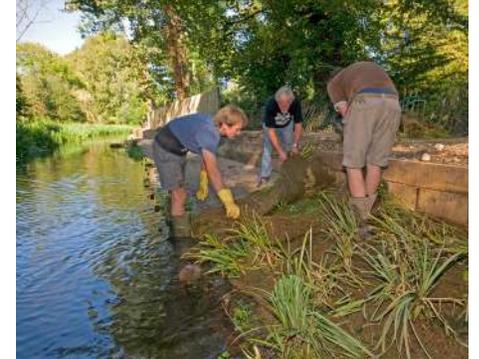
Plants sourced from the Itchen and grown on in a nursery are installed by contractors, providing 'instant habitat'.

In front of both types of repair, a gently-sloping 'berm' of bankside vegetation was created along the river's margins. Hazel faggots were used to edge the berm, and the area behind was planted with a combination of directly sourced plants and pre-planted coir mats, rolled out and installed just like carpet.

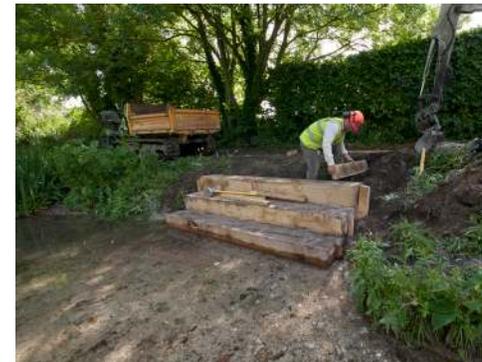
A 'Dog Dip' being constructed, to allow access to the water whilst preventing bank erosion

Two 'Dog Dips' were also installed in areas where access to the channel was common, providing a novel way of protecting adjacent wildlife habitat from trampling.

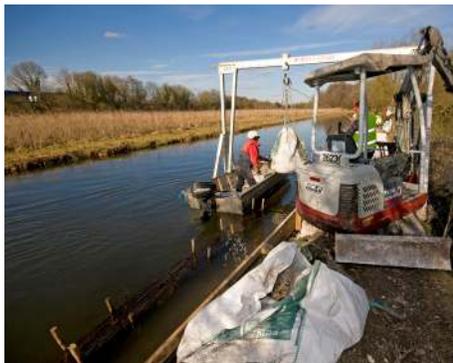
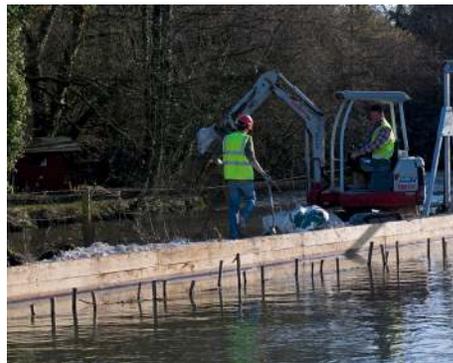
Boat transport was safer and lower-impact than using heavy machinery Images: Dennis Bright

Instead, materials were delivered by road to an adjacent woodland copse, packed into individual 300kg bags. A mini-digger carried the bags one by one over a temporary trackway through the woodland, and loaded them into a flat bottomed boat at the water's edge. The boat transported the materials downstream, again one at a time, to a mobile gantry, where they were unloaded and utilised by a second mini-digger. The digger placed materials in front of it, working its way upstream towards the site entrance, moving only onto sections of bank that it had just repaired.

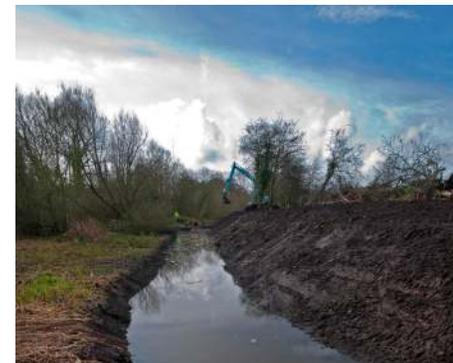
At Mansbridge Fen, an excavator clears a silted-up ditch to encourage the spread of fen vegetation

Early in 2011, habitat enhancements were undertaken at the adjacent Mansbridge Fen, through tree removal and ditch restoration. Volunteers are continuing to help manage the fen through the control of scrub and of non-native species.

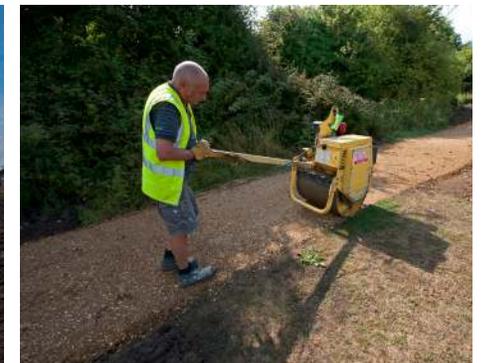
Footpath raising, realignment and resurfacing improve accessibility and limit erosion of surrounding habitats. Images: Dennis Bright

A programme of tree and scrub control commenced, and in summer 2010, works were undertaken to raise, realign and resurface the eroded footpaths, and to replace stiles with kissing gates to improve accessibility.
